**CITY OF BALTIMORE WET WEATHER CONSENT DECREE  
SMOKE AND DYED WATER TESTING FORM**

Test ID: S1039-001

CITY OF BALTIMORE  
SMOKE TESTING OBSERVATION SUMMARY  
OUTFALL SEWERSHED  
BALTIMORE CITY PROJECT 1039  
REI/DRAYCO

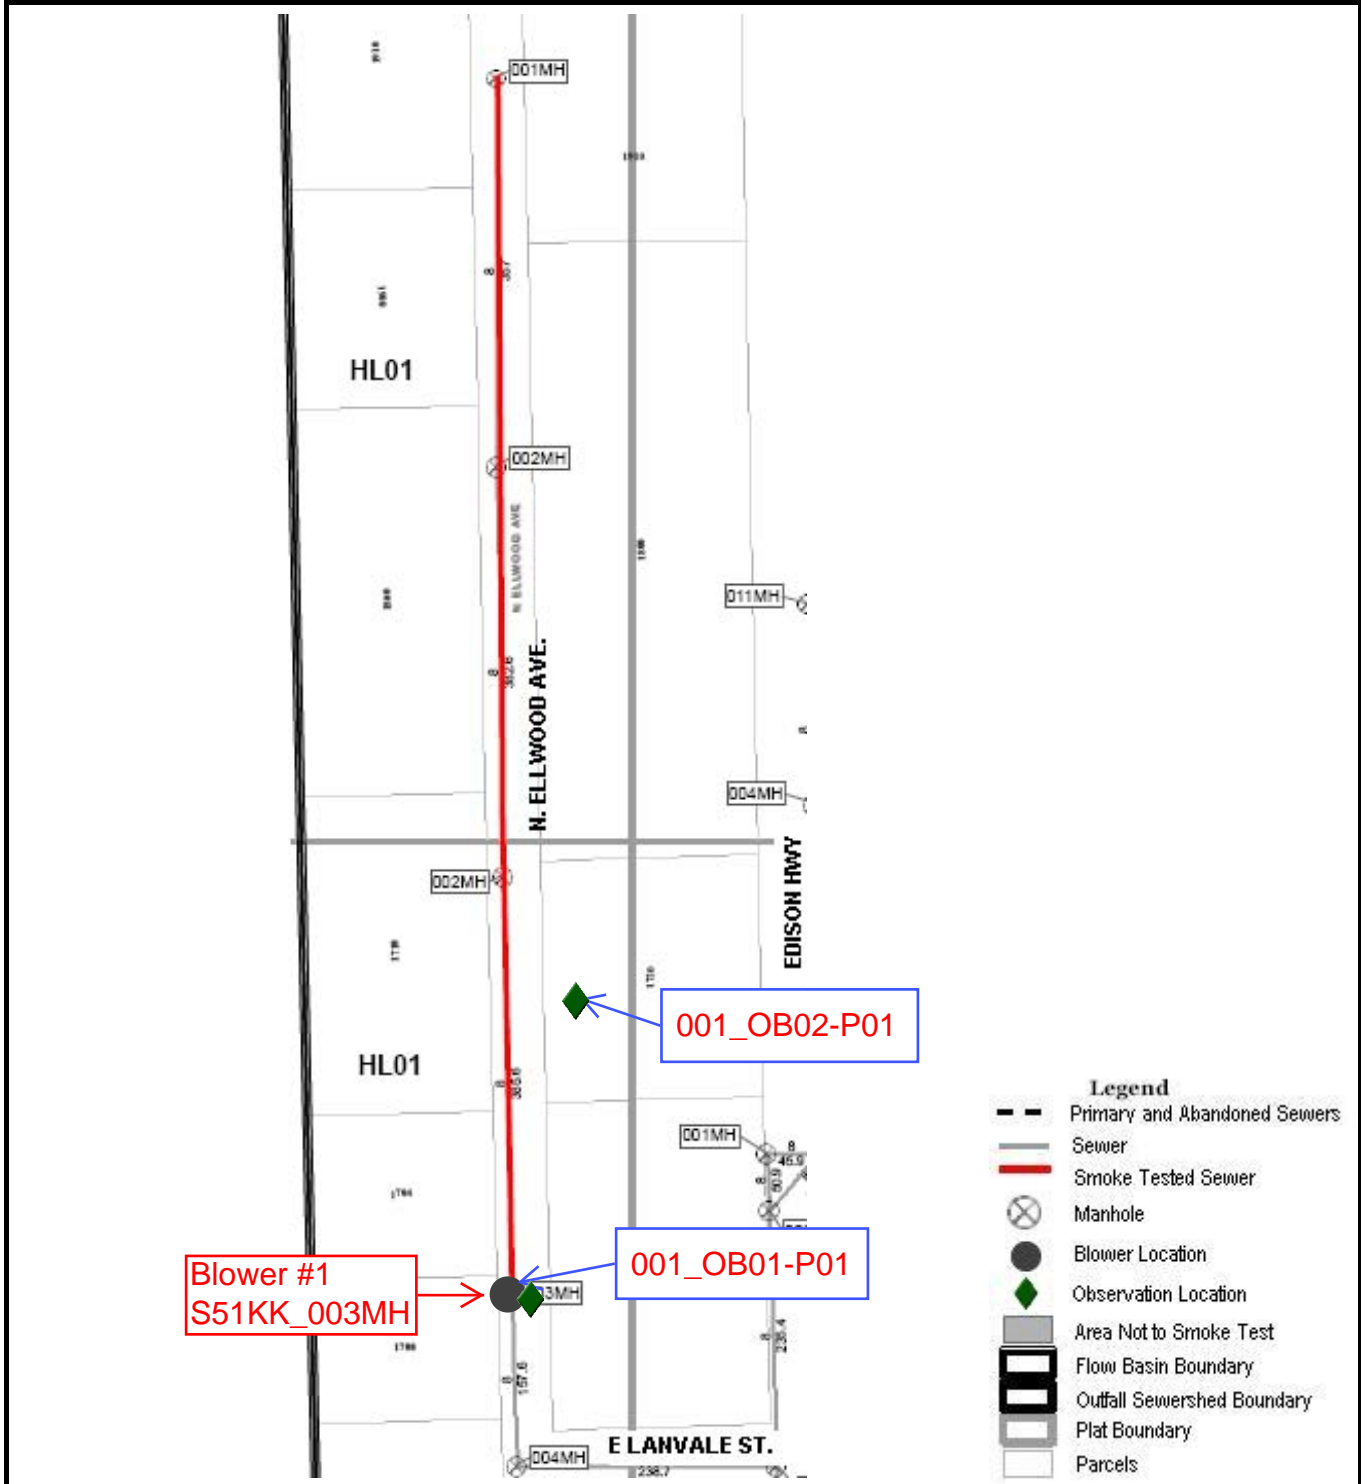
Field Sketch: (Show all manholes with numbers, blower placement location, sandbag or isolation locations, street names, building addresses and locations, defect locations and photograph numbers)

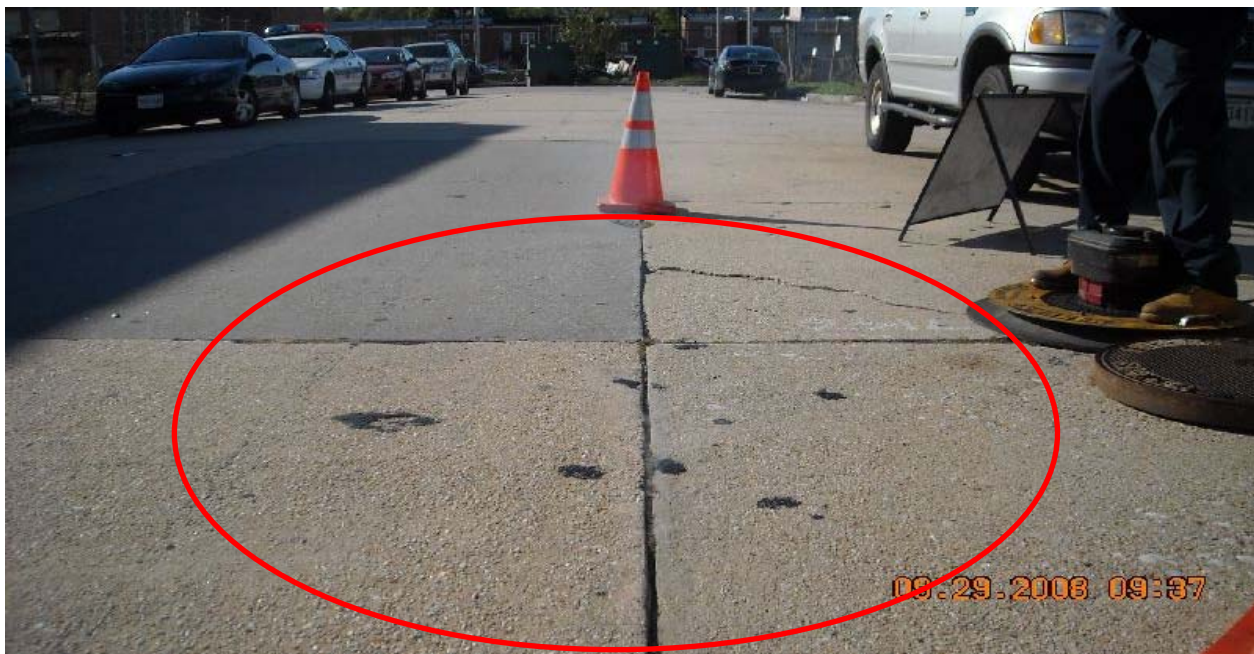
Photograph No: OB01-P01  
Filename: S1039-001\_OB01-P01.jpg

Unique Test ID: S1039-001	Date: 09/29/2008	Manhole ID: S53KK_003MH
Defect No: OB01	Supervisor: E.R.	Basin: Outfall
Location: 1700 N. ELLWOOD AVE.		
Source Type: 01 Main Sewer	Sector: 01 Public	
Location: 01 Paved Concrete	Severity: 03 Moderate	Drainage Area: 65 ft <sup>2</sup>
Comments: Smoke is coming from between cracks in concrete between site of orange cone and the foreground of photograph, also extending horizontally across picture to the manhole.

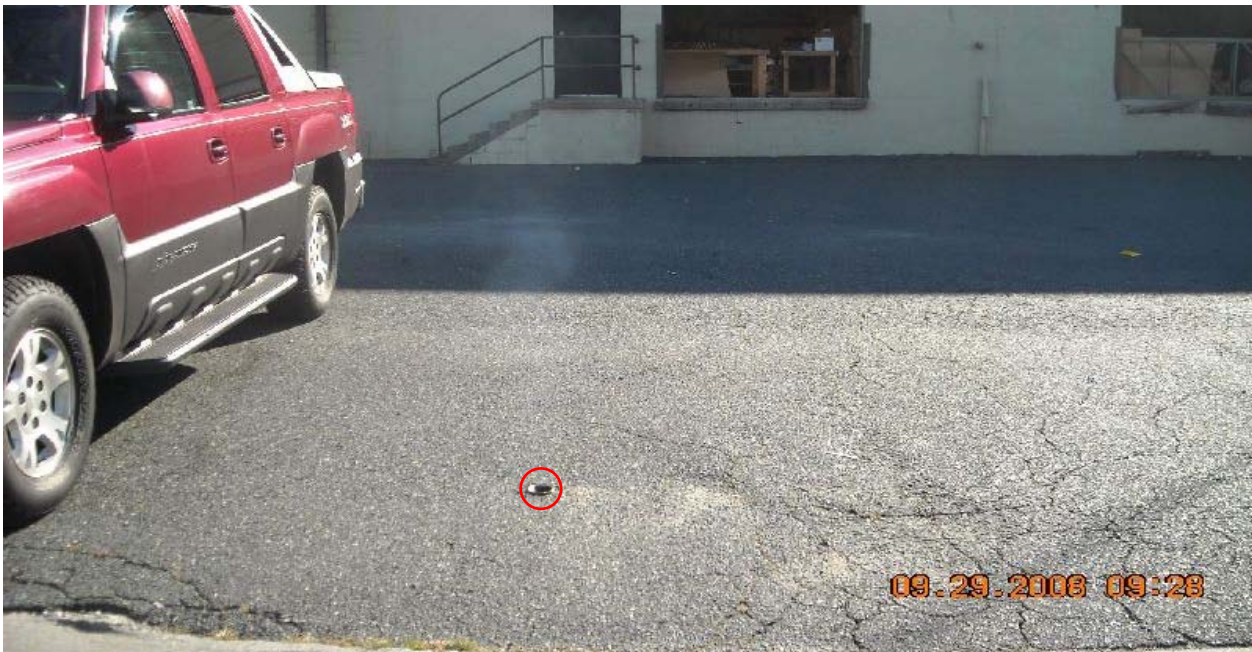
Photograph No: OB02-P01  
Filename: S1039-001\_OB02-P01.jpg

Unique Test ID: S1039-001	Date: 09/29/2008	Manhole ID: S51KK_003MH
Defect No: OB02	Supervisor: E.R.	Basin: Outfall
Location: 1720 EDISON HWY.		
Source Type: 03 Cleanout	Sector: 02 Private	
Location: 02 Asphalt	Severity: 03 Moderate	Drainage Area: 1 ft <sup>2</sup>
Comments: Smoke is coming from the cleanout in the rear parkinglot of building.
